WALKABILITY ASSESSMENT

GREATER SPRING HILL COMMUNITY
DELAND, FLORIDA

Greater Spring Hill Community Walkability Assessment Report

May 2018

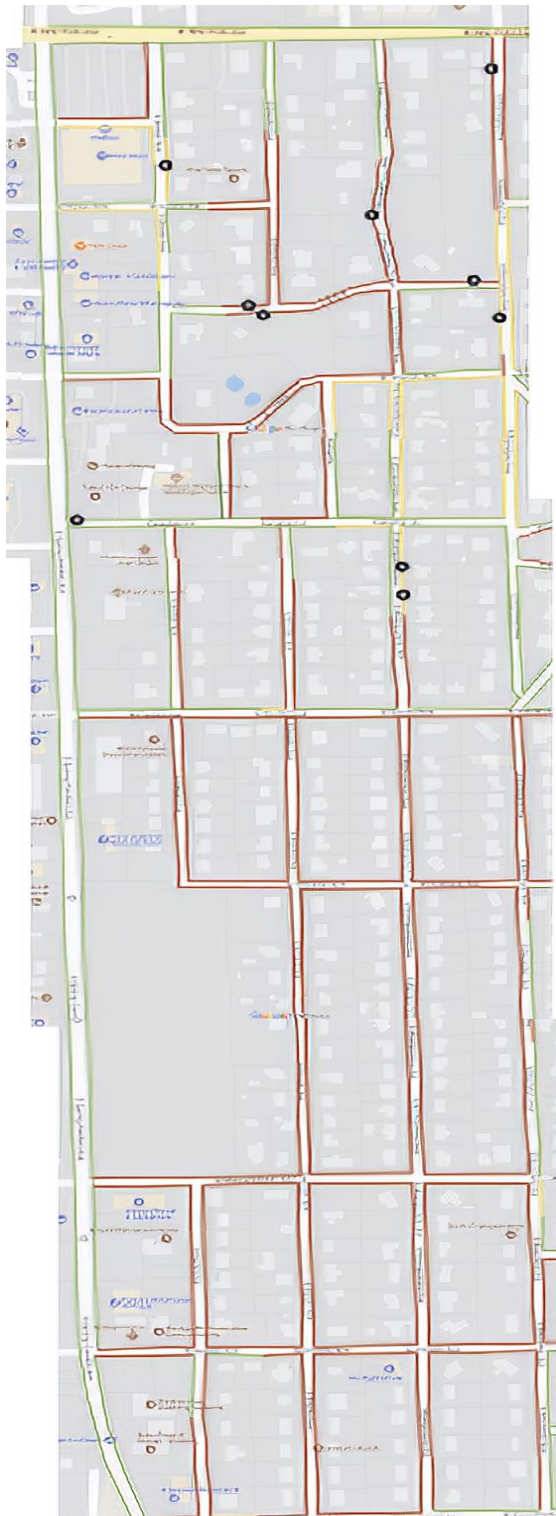
Figure 4. Region 3 Sidewalk Infrastructure Map

Region 3, as shown in Figure 4, is bordered by W New York Ave to the north, S Boundary Ave to the east, W Euclid Ave to the south, and SR-15 to the West. The area within Region 3 is fully incorporated into the city of DeLand. The overall walkability score for this region is 3.95 out of a possible 21 points. 40.0% of streets in this region have a continuous sidewalk on at least one side of the road. 80.0% of streets have some degree of trip hazard present. 70.0% of streets in this region have some degree of street lighting and 10.0% of streets have less than 50% of the buildings well maintained. There was no graffiti tagging found in this region. None of the streets in this region were found to have bike paths or transit stops present. As shown in Figure 4, there are a number of impediments to walking found in the northern half of Region 3. Only one of these impediments, located on SR-15, was found along a sidewalk that was not otherwise damaged. While Region 3 does not have any churches, schools, or parks present there are many businesses located along SR-15 where sidewalk is present.

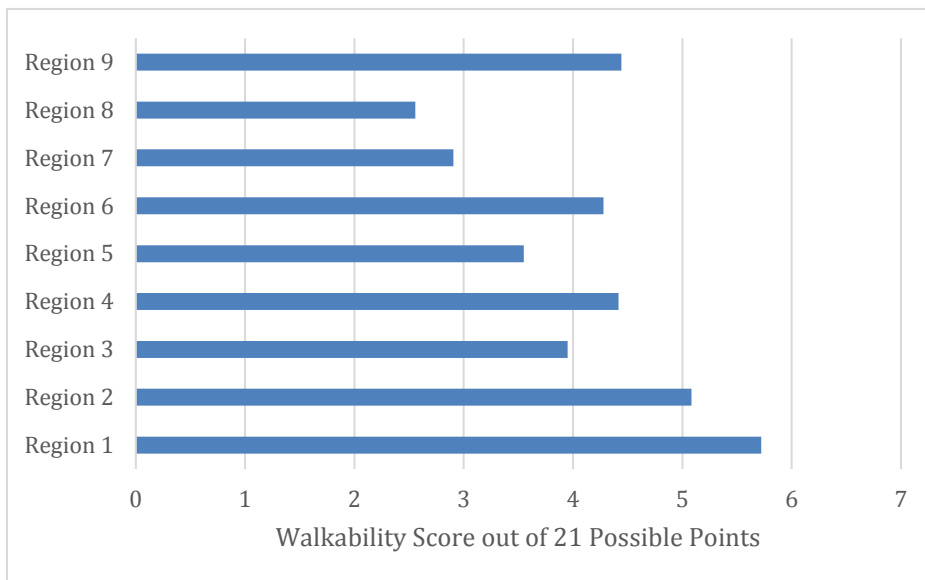
Figure 11: Walkability Score by Region

Table 11 shows the average walkability score for each of the designated regions which is based on a 21-point scale. Region 1 had the highest score with an average of 5.72. Region 2 had a score of 5.08. The walkability score for Region 3 was 3.95. The score for Region 4 was 4.42 out of 21. Region 5 had a walkability score of 3.55. The average walkability score for Region 6 was 4.28. Region 7 had a walkability score of 2.90. Region 8 had the lowest walkability score amongst all the other regions, with an average of 2.56 out of 21 points. Region 9 had a score of 4.44

Overall walkability among all regions was found to be very low, ranging from 5.72 out of a possible 21 points in region 1 to 2.55 out of a possible 21 points in region 8. Regions 6-9 within the Spring Hill CRA were found to generally have lower walkability scores (average of 3.54) than regions 1-5 found outside the Spring Hill CRA (average of 4.54).

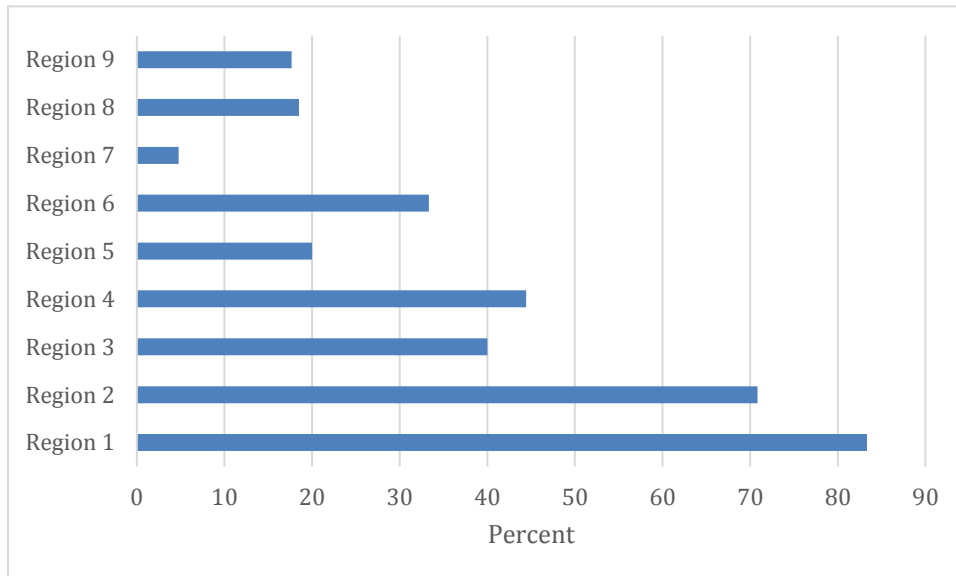
Figure 12. Streets with Continuous Sidewalks on at Least One Side of the Road, by Region

Figure 12 portrays the connectivity of sidewalks on at least one side of the road. About 83.3% of the streets in Region 1 had continuous sidewalks on at least one side of the road. 70.8% of the streets in Region 2 had continuous sidewalks. In Region 3, 40% of the sidewalks were continuous and in Region 4 44.4% of the sidewalks were continuous on at least one side of the road. 20% of the streets in Region 5 have a continuous sidewalk. In Region 6, 33.3% of the streets were continuous on at least one side of the road. Region 7 had the lowest connectivity amongst sidewalks when compared to the other with only 4.8% streets being continuous. Region 8 and Region 9 had 18.5% of streets and 17.6% of streets with continuous sidewalks on at least one side of the road, respectively.

The greatest discrepancies in variables contributing to overall walkability scores were found in sidewalk connectivity. Percent of streets with continuous sidewalk on at least one half of the road, defined in the survey as “continuous sidewalk”, ranged from 83.3% (n=30) in region 1 to 4.8% (n=1) in region 7. Continuous sidewalk was found in 58.3% (n=63) of streets outside the Spring Hill CRA, while only 16.2% (n=12) of streets in the Spring Hill CRA were found to have a continuous sidewalk. Percent of continuous sidewalk in a region was found to have a positive correlation with walkability score ($r=0.863$), meaning that regions with more sidewalk connectivity were also generally found to have higher walkability scores.

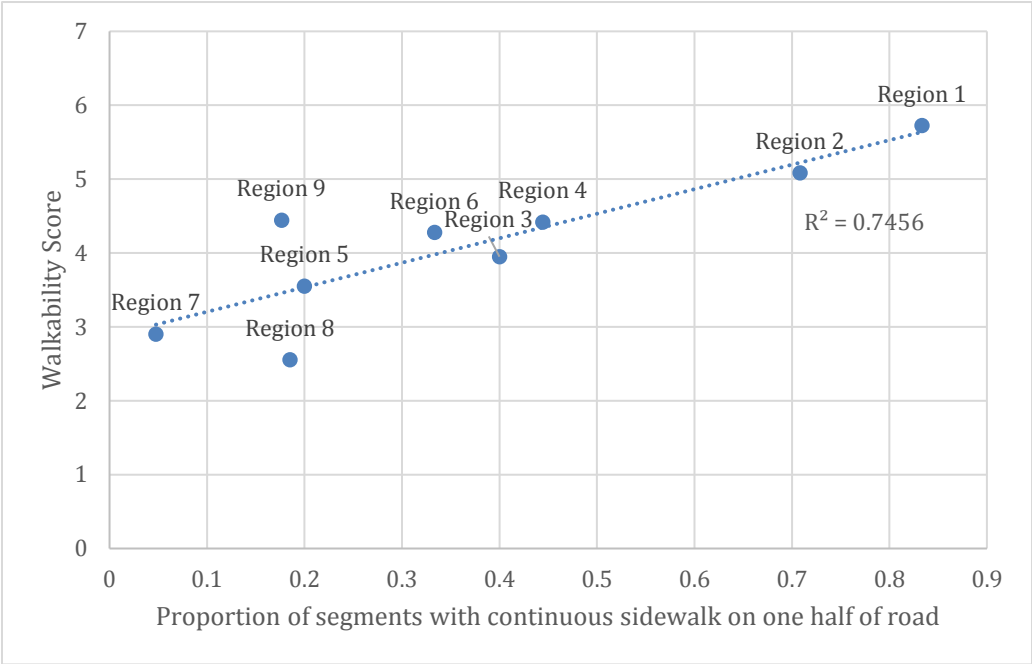
Figure 13. Relationship of Walkability Score to Proportion of Continuous Sidewalk Within each Region

Figure 13 shows a linear regression conducted to determine the relationship between sidewalk connectivity and walkability score between regions. The results found that increased percentage of continuous sidewalk on at least one half of the road is positively correlated with an increased overall walkability score ($r=0.863$).

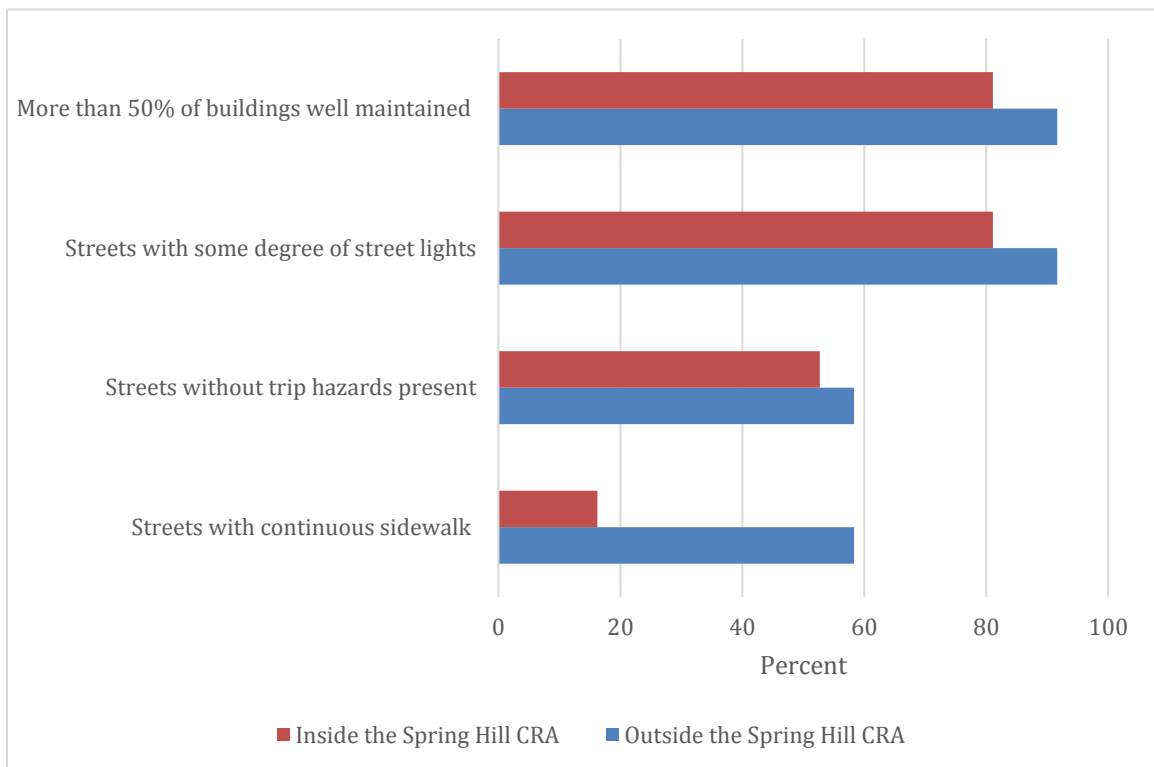
Figure 14. Comparison of Select Walkability Variables in Regions Outside the Spring Hill CRA (1-5) vs. Inside the Spring Hill CRA (6-9)

Figure 14 shows the comparison of variables effecting walkability inside the Spring Hill CRA (defined by regions 6-9) and outside the Spring Hill CRA (defined by regions 1-5). Within 91.7% of streets outside the CRA were found to have more than 50% of the buildings well maintained, while 81.1% of streets inside the CRA were found to have more than 50% of the buildings well maintained. The same numbers were found for streets that have some degree of streetlights with 91.7% inside the CRA and 81.1% outside the CRA. 58.3% of streets outside the CRA were found to be free of trip hazards while 52.7% of streets inside the CRA were found to be free of trip hazards. The number of streets with a continuous sidewalk on at least one half of the road was found to be 58.3% in outside the CRA, while 16.2% of streets inside the CRA were found to have continuous sidewalk on at least one half of the road.

Differences exist between the overall walkability of regions located within the Greater Spring Hill Community north of Beresford Ave (1-5), referred to as outside the Spring Hill CRA, and areas of the Greater Spring Hill Community south of W Beresford Ave (6-9), referred to as the Spring Hill CRA.

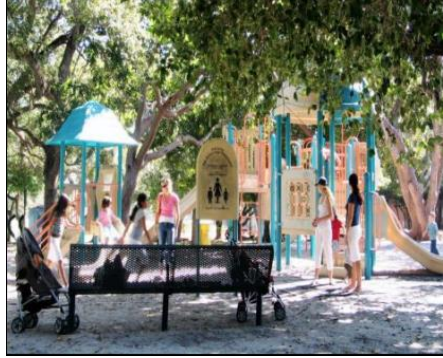
A public park should only be counted if they can be accessed along the route walked. Do not count parks beyond the route even if they can be seen from the route.

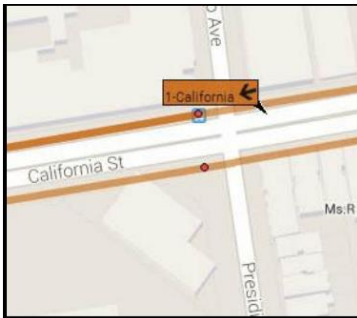
One Stop

Transit stops located across the street from each other may be counted as '1' stop, as long as they service the same transit line. If the stops are far enough away that a transit user could not quickly run across the street to catch a bus, count '2'.

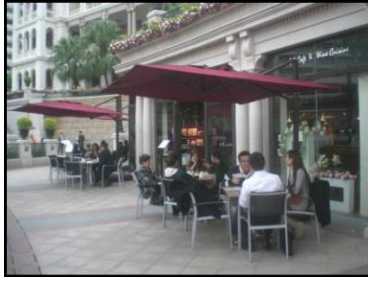
Tables or benches outside of restaurants/cafés (see picture) do not count as a places to sit. These must be public seating areas.

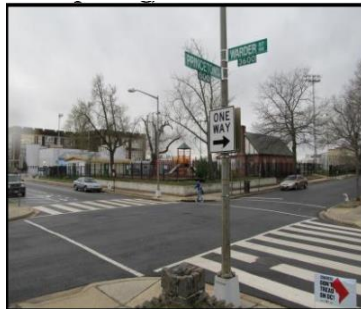
Some (e.g., overhead street lights on utility poles with wide

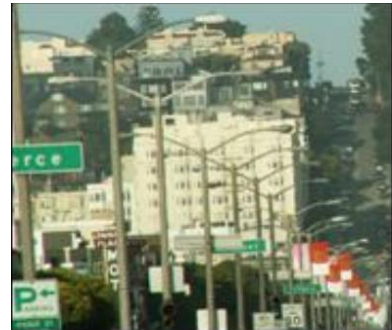
Ample (e.g., regularly spaced pedestrian lamp posts)

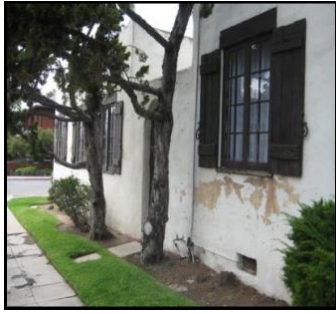
Buildings not well maintained (one or more buildings like this)

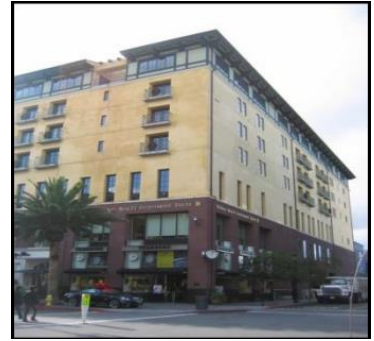
100% of buildings well maintained

Buildings do not need to be brand new to get a 100% rating. They just need to be well kept and maintained.

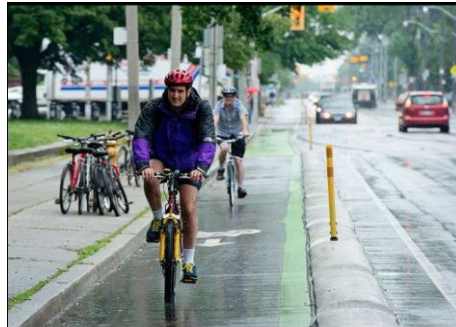
Bike lane separated from

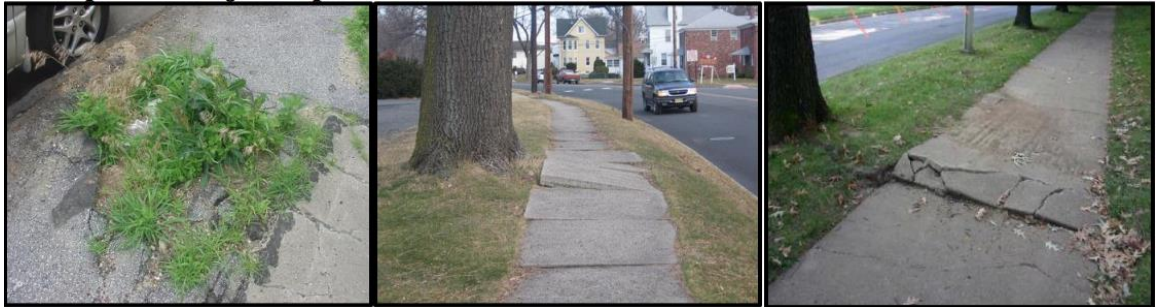
Examples of major trip hazards

Major Trip Hazard: An increased likelihood of tripping due to a raising or lowering in the walkway. A hazard could be due to plants, tree roots, or general erosion. A major trip hazard would require pedestrians to look down to avoid

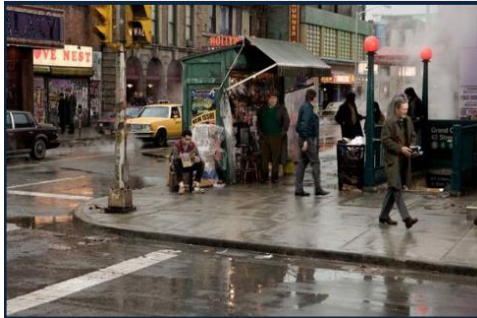
No Buffer

Buffer: Separates vehicular and pedestrian zones parallel to the edge of paved roads. They often occupy space between traffic lanes and walking paths that is not intended for either vehicle traffic or walkers. Any buffer on a segment, no matter how long, will be counted

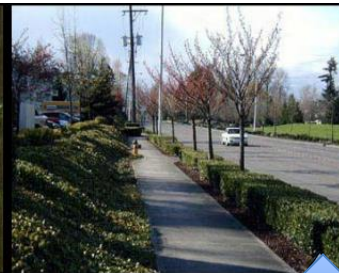
Shrub Buffer

- Tree plantings, telephone poles or parking meters should not be considered as a buffer if there is, on average, more than 20 feet between them along the street segment.
- A bike lane does not count as a buffer.
- Brick alone next to a sidewalk would not be counted as a buffer because it is not inhibiting cars from coming onto the sidewalk.

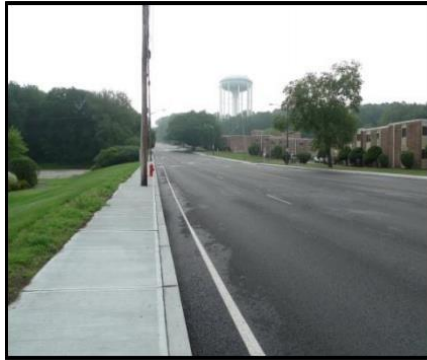
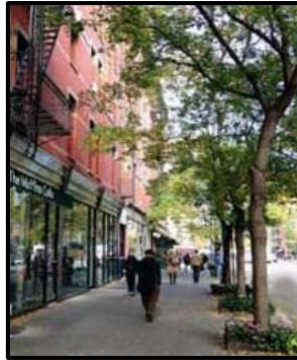
26-75% coverage

76-100%

"Coverage" is the percent of the length of walkway covered by trees, awnings, or other structures providing shade. It need not cover the entire width of the sidewalk. Depending on the time of the year, trees may lose their leaves, so make sure to visualize the trees with their full foliage, in the middle of the day.

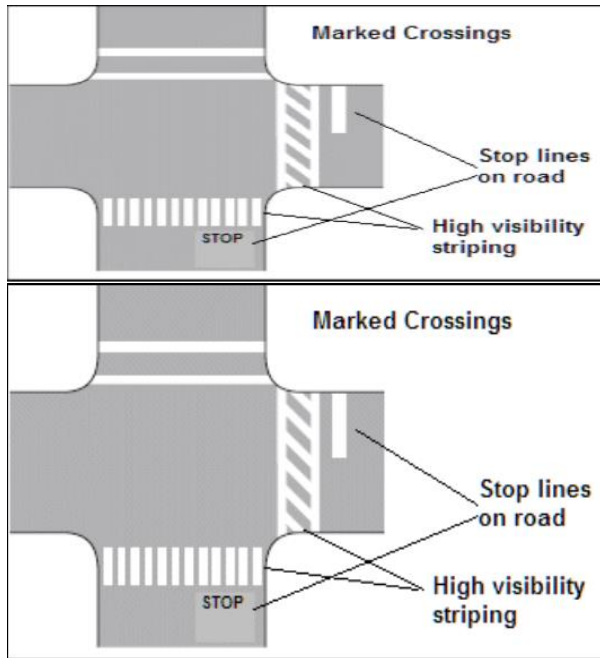
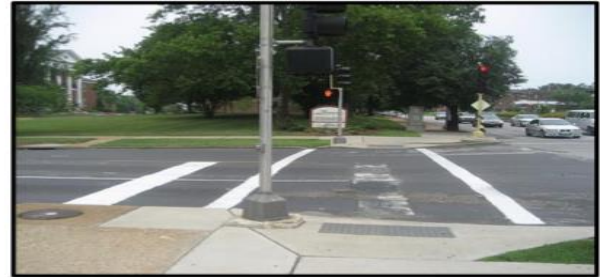
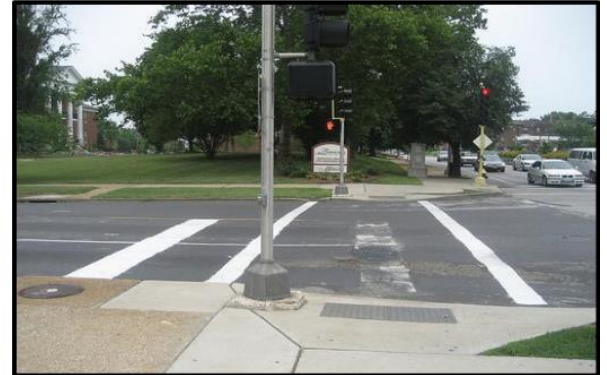
Marked crosswalk: A crosswalk is a designated point on a road at which some means are employed to assist pedestrians wishing to cross. They are designed to keep pedestrians together where they can be seen by motorists, and where they can cross most safely with the flow of vehicular traffic. Pedestrian crossings are often at intersections, but may also be at other points on busy roads that would otherwise be
